Safety Enhancement of Nuclear Power Plant Post Fukushima

October 31,2013

Hitachi-GE Nuclear Energy, Ltd.

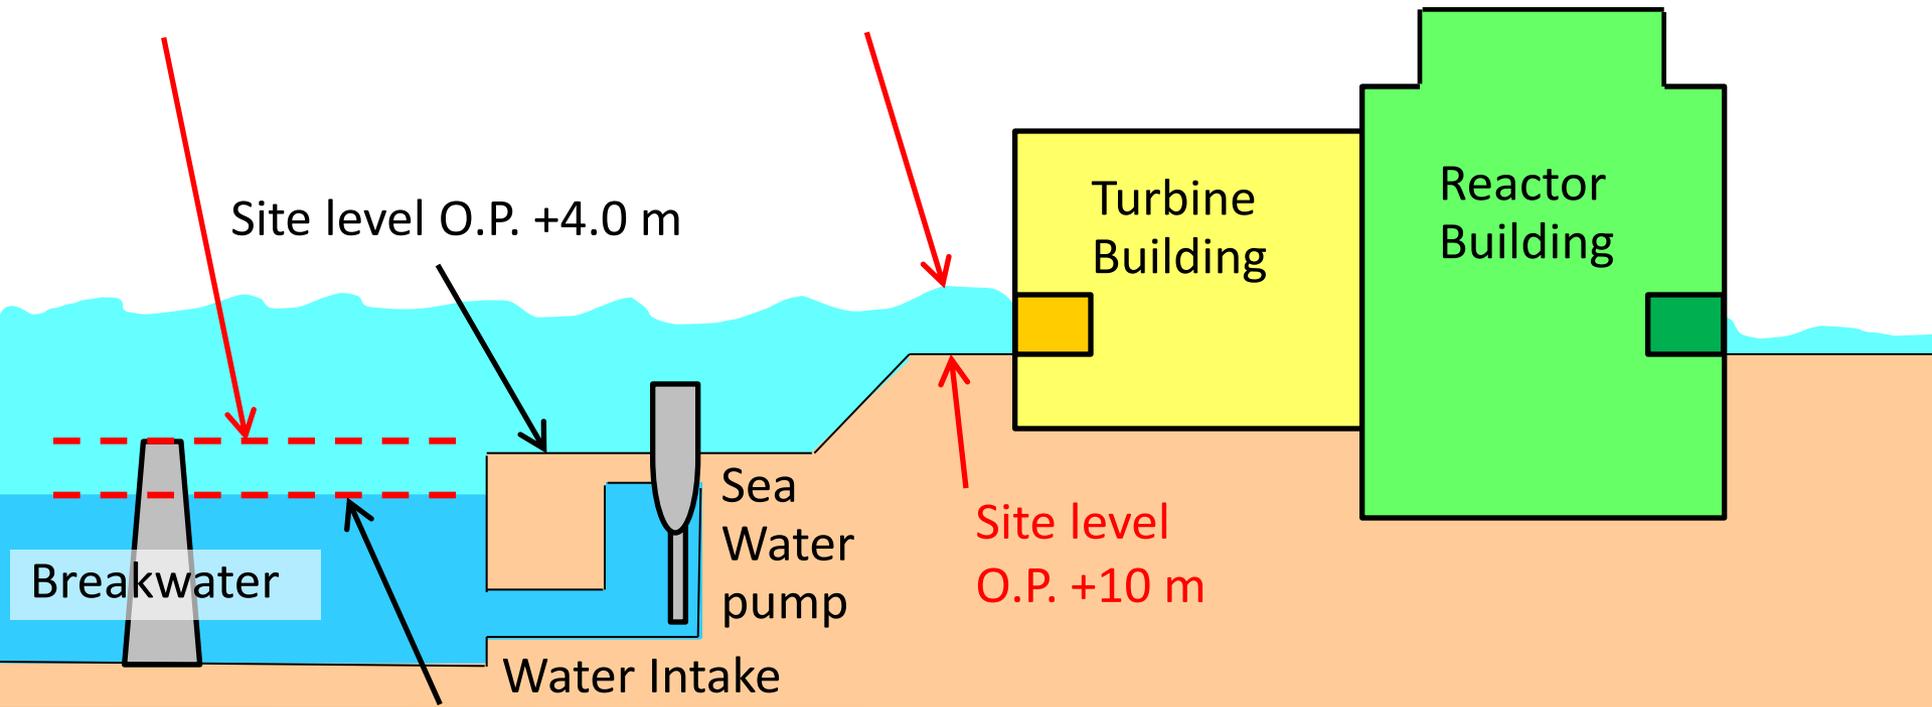
Inundation height was fatally higher than assumed tsunami water level

Assumed tsunami
Water level O.P. +5.7 m

Inundation height
Approx. O.P. +14 m

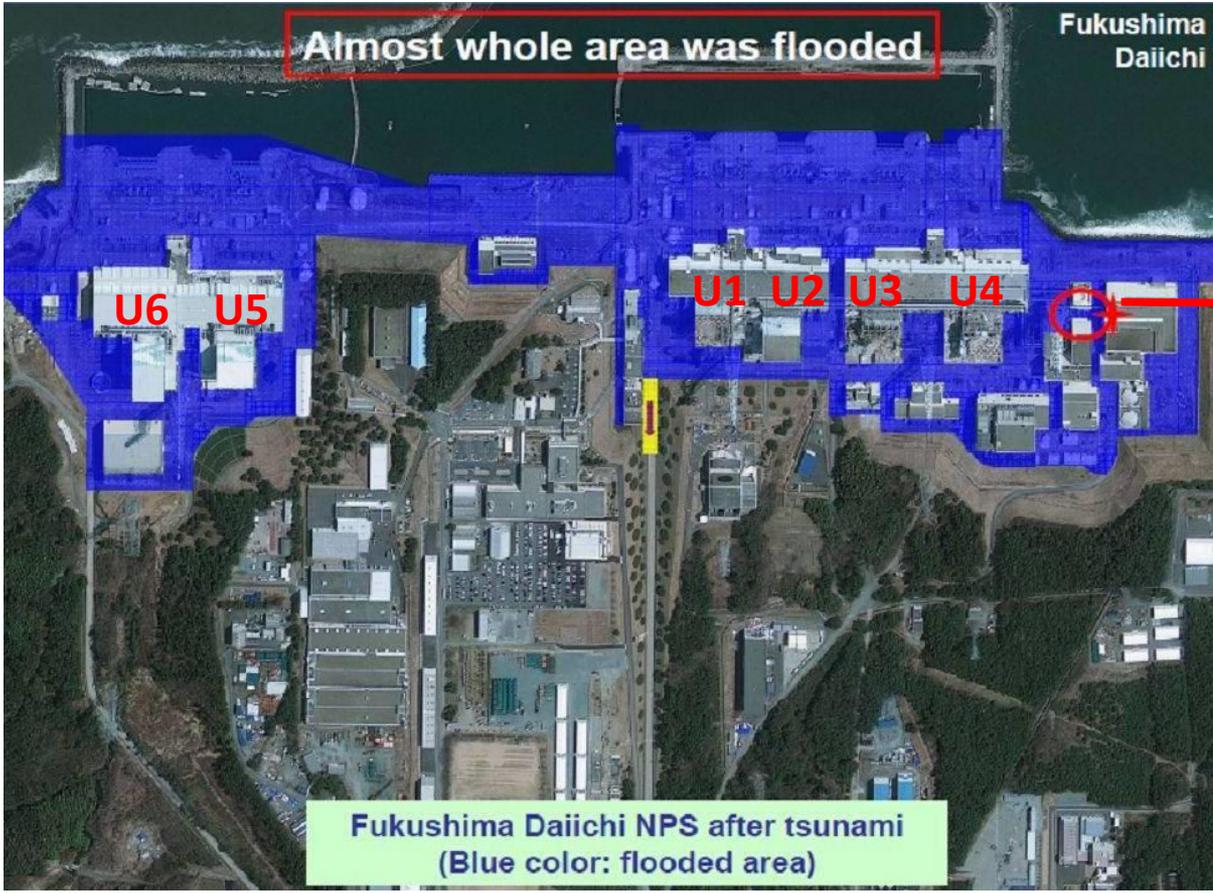
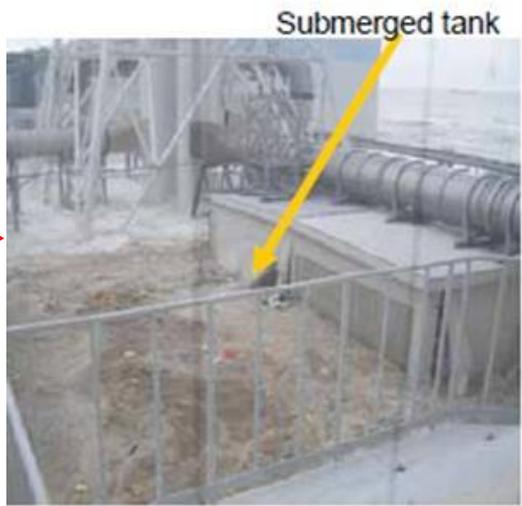
The sea water flooded into buildings through louver of ventilation, broken shutters and so on.

The whole area of Fukushima Dai-ichi site was inundated by sea water at a height of around 5m.

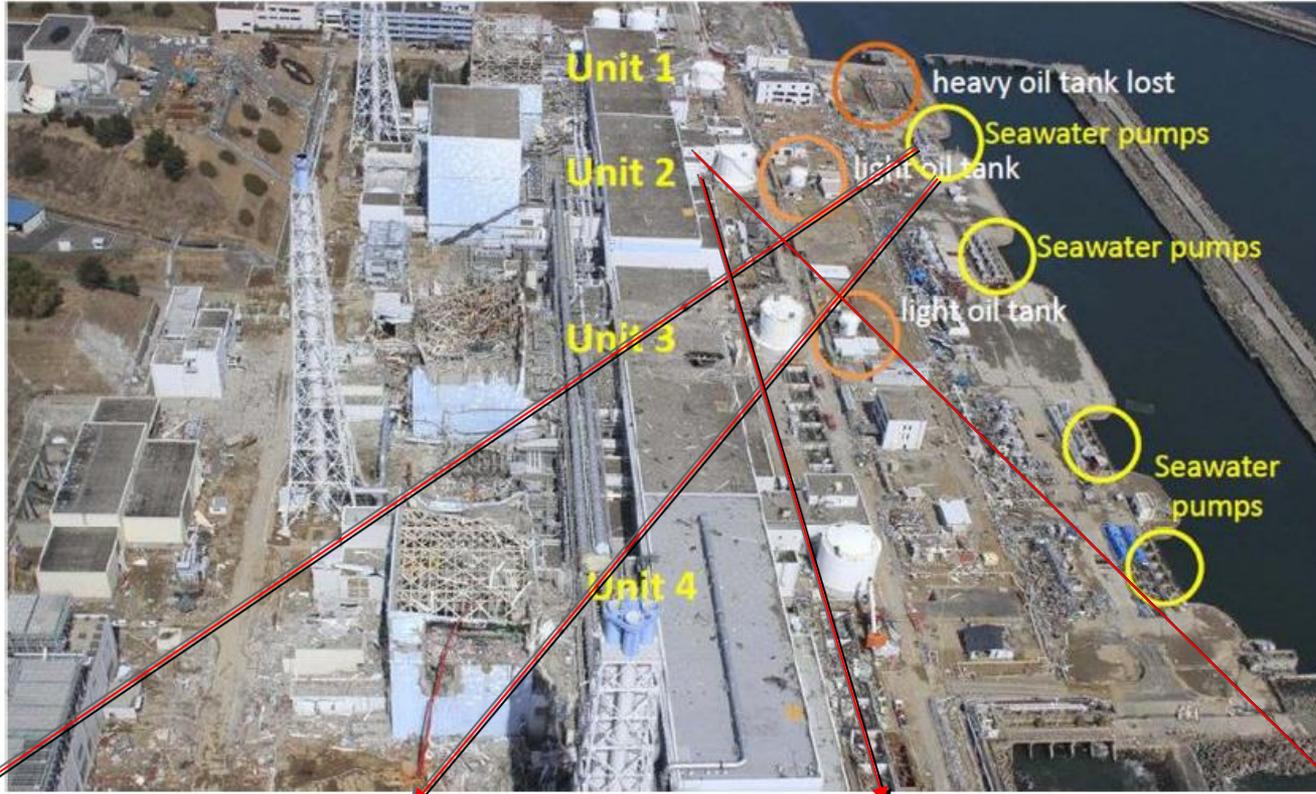
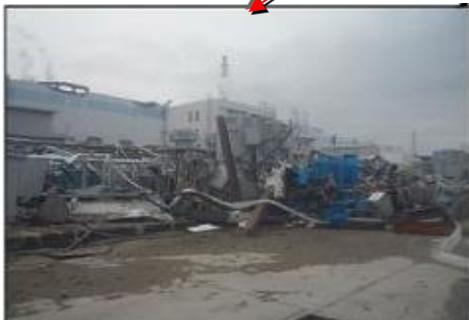
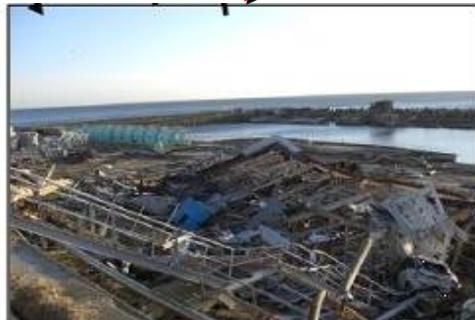
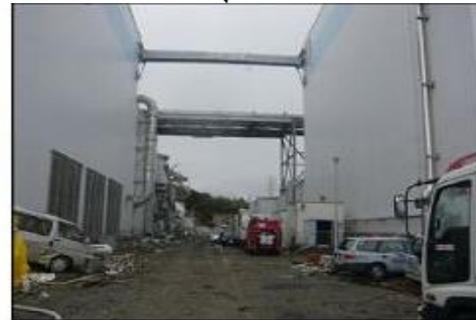
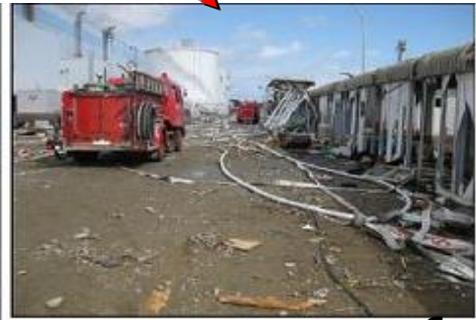
Tsunami destroyed many facilities outside plants

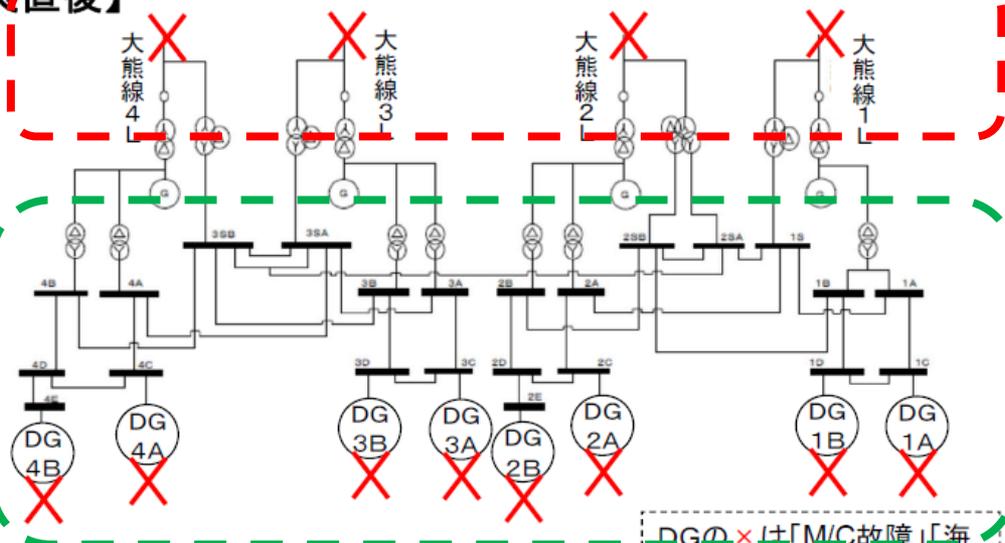
Unit 1 to Unit 4

生き残った電源なし

大熊線1L、2L
地震時に受電遮断器損傷
大熊線3L
改造工事中
大熊線4L
停止した原因を調査中

Damage by Earthquake

Damage by Tsunami

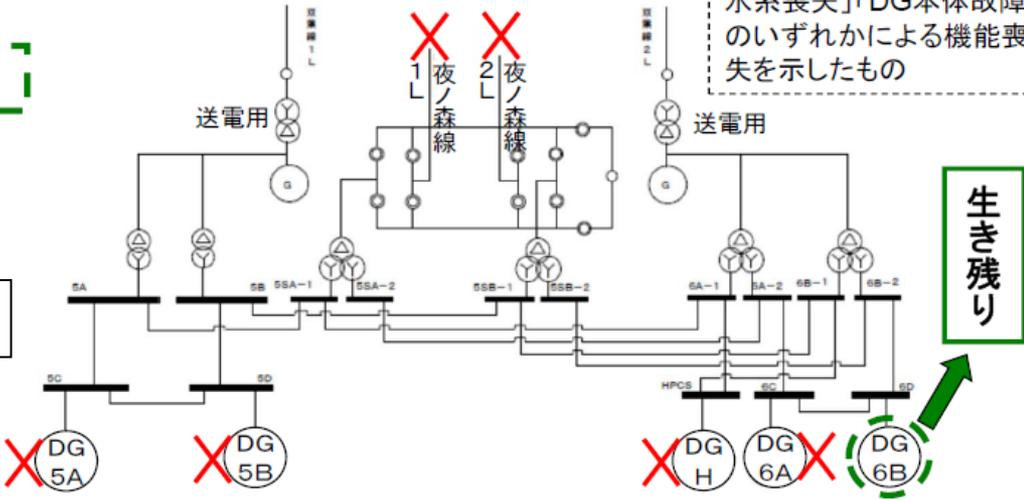
Unit 5 and 6

生き残りはDG6Bのみ

夜ノ森線1L, 2L
鉄塔が一部倒壊

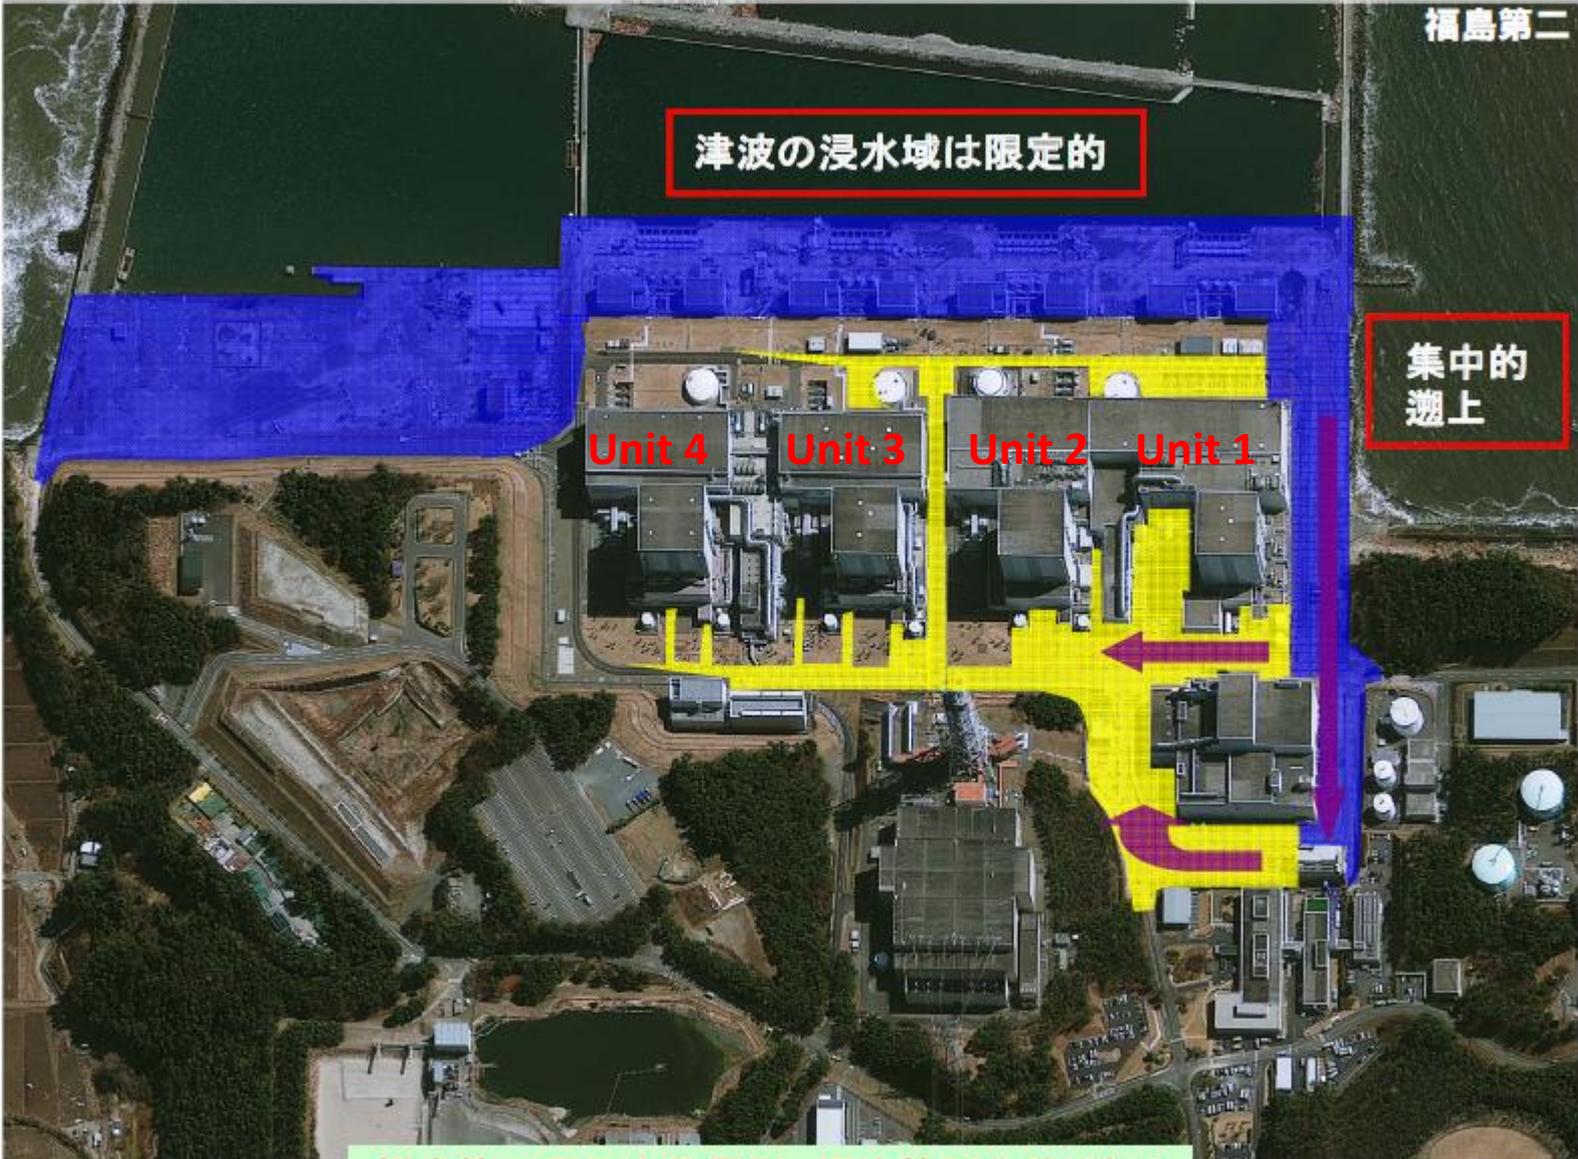
2.8 Effect of Tsunami in Fukushima Dai-ni

福島第二原子力発電所 浸水箇所色塗りあり
